## Evaluation of Protection of FRP Wrap on Bridge Piers from Corrosive Effects of Snow and Ice Chemicals

Honors Thesis

Department: Civil and Environmental Engineering

April 2017

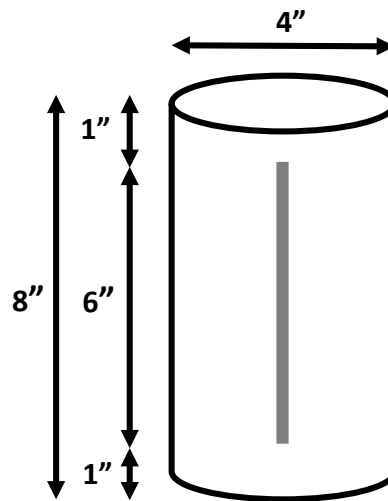
The test samples observed during this study were eight inch long by four inch diameter cylinders. Nineteen cylinders were filled with the above specified concrete mix. Within fourteen of the nineteen cylinders, a six inch long  $\frac{1}{2}$ " diameter piece of reinforcing steel was placed, in order to increase the potential for chloride ions to penetrate the concrete. The steel was longitudinally centered, leaving approximately one inch of concrete cover above and below the steel, as seen Figure 1 below. The steel was also laterally centered in the cylinder, leaving about 1.75" of cover on either side.

*Figure 1: Reinforced Cylinder Setup*

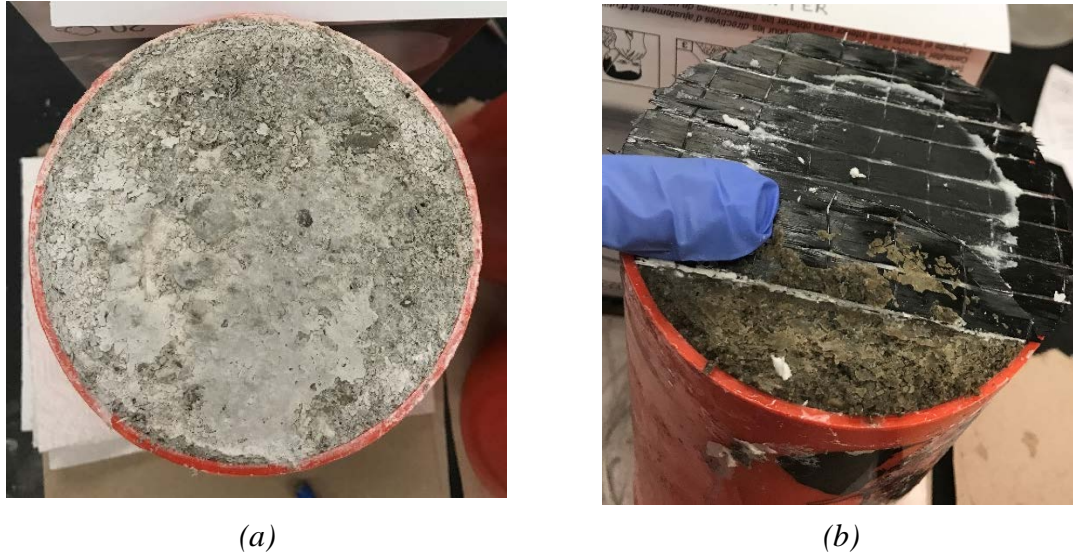
Overall, all surfaces of the concrete cylinders degraded throughout the test cycles, regardless of whether they had a FRP covering or not. However, the location of disintegration of concrete did vary from covered to uncovered sample. As seen in Image 1a below, almost the entire surface area of the cylinder was affected. Contrastingly, only the edges of those samples covered in CFRP were affected. However, the concrete on the edges that was affected for covered samples was much more degraded than the concrete of the uncovered samples. As seen below in Image 1b, the edges were often chipped away, or fell away after light handling. Those samples with GFRP had degradation of the concrete on the edge of the cylinders, similar to that of the CFRP cylinders, however, degradation was much less drastic; the degradation was similar to that of uncovered samples, if not much less. Observations for all cylinders after ASTM C666 can be seen in Table A.3 in the Appendix.

*Image 1: (a) Degradation of Uncovered Exposed Concrete Sample, (b) Degradation of CFRP Covered Exposed Concrete Sample*

The surface layer of those with the CFRP cover were degraded far more than those with a GFRP cover or those even without a cover. CFRP was also debonded in far more instances than the GFRP. This could be due to the lack of perpendicular strands holding the 0° strands together, as seen in the GFRP. Without this perpendicular strand, there were more opportunities for the calcium chlorine to get through to the concrete specimen. However, this reasoning does not necessarily explain why the CFRP would, in some cases, provide a *worse* result than those cylinders that were not covered. Further investigation may have to be done to determine any chemical interactions occurring in between the calcium chloride and CFRP.

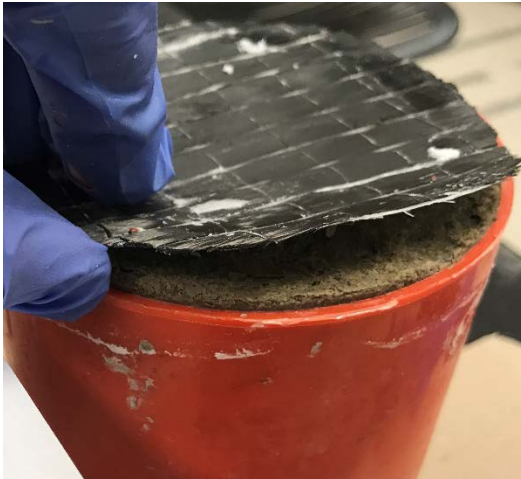
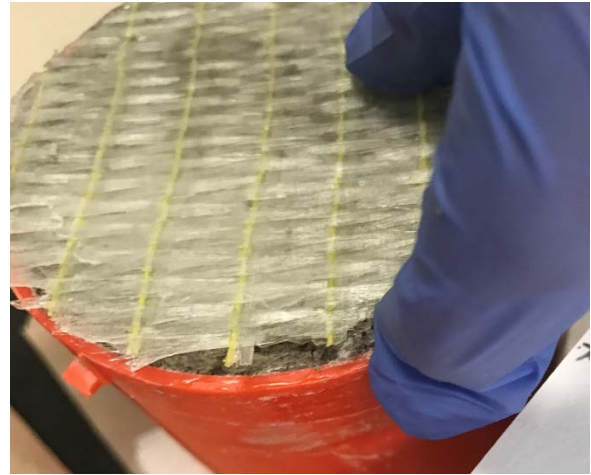
However, debonding occurred for a large amount of samples, sometimes over the majority of the surface area of the sample. Those samples covered with CFRP experienced significantly more debonding as opposed to those samples covered with GFRP. All CFRP-covered samples showed signs of debonding, with three of them having significant amounts of separation. Conversely, those samples covered with GFRP showed far less signs of debonding after testing. Only significant amounts of debonding occurred in one of the GFRP samples, while the rest of the samples had signs of separation similar to that shown in Image 2b below. Observations for all cylinders after ASTM C666 can be seen in Table A.3 in the Appendix.

*Image 2: (a) Debonding of CFRP; (b) Debonding of GFRP*

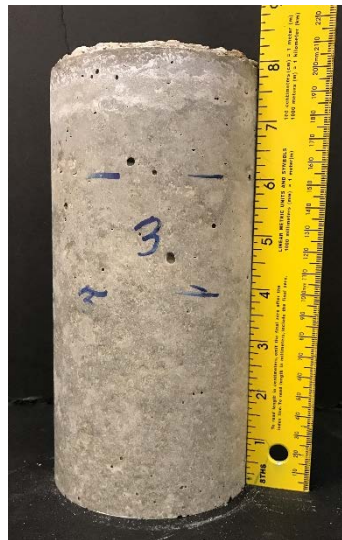
- Rating 1: Chloride concentration evenly spread throughout; not overly concentrated in one area; “pale”

After removing the outer mold from the concrete cylinder, the depth of intrusion was measured on all samples. Additionally, each concrete cylinder was given a rating pertaining to the concentration of chloride visible. Below are listed the characteristics of each rating, along with a correlating example image:

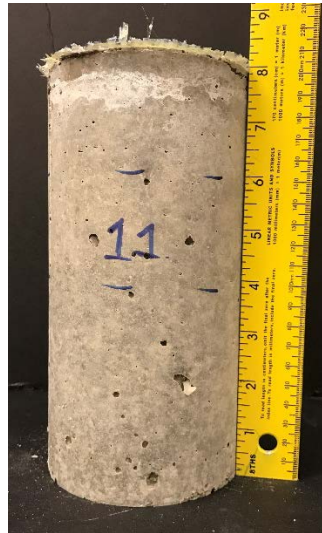
- Rating 2: Chloride concentration seen in dark patches scattered throughout affected zone

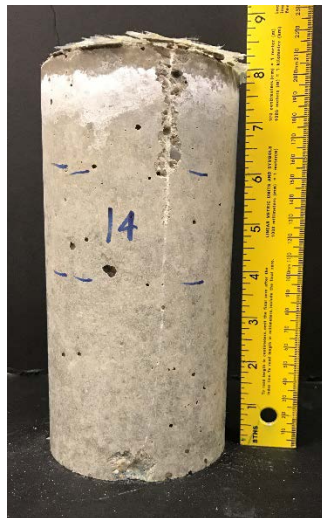
- Rating 3: Large, dark, chlorine-heavy areas clearly seen; heavy bands of chloride around entire perimeter of cylinder

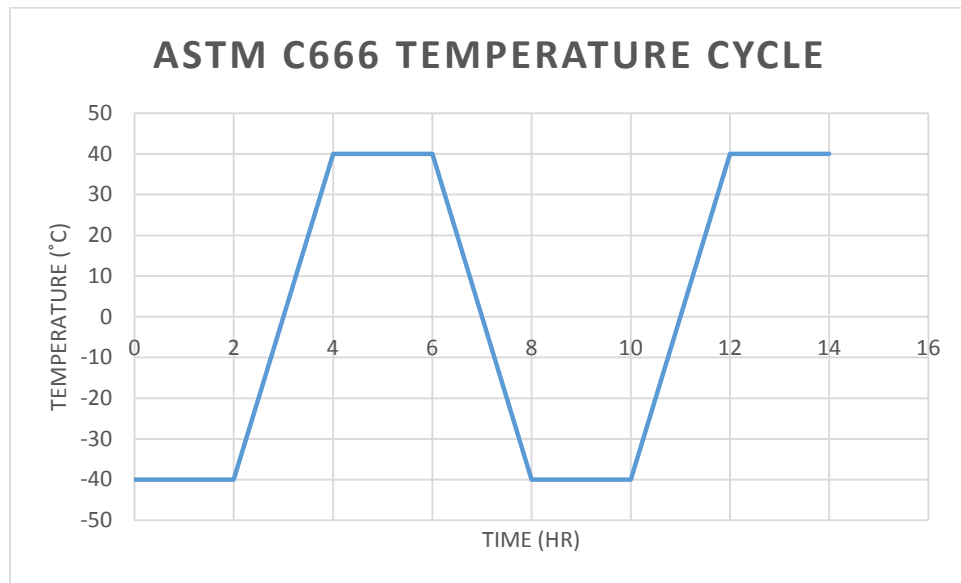
**Table A.5: ASTM C666 Cycle Description**

**Cycle Length = 6hr**

**Cycle Timeline = 57 days, 228 cycles**

The ten FRP covered samples, as well as two uncovered and reinforced samples, were placed in a temperature-controlled chamber. The chamber fluctuated from -40° C to 40° C, each cycle lasting six hours. Overall, the cylinders were exposed to 228 cycles total, remaining in the temperature chamber for eight weeks.

During the first two weeks, as well as the last two weeks, all of the cylinders were exposed to a 32% solution of calcium chloride. The cylinders were sprayed with 10 mL of this solution once a day during these four weeks. Therefore, overall, the cylinders were exposed for approximately 114 cycles to the calcium chloride solution.

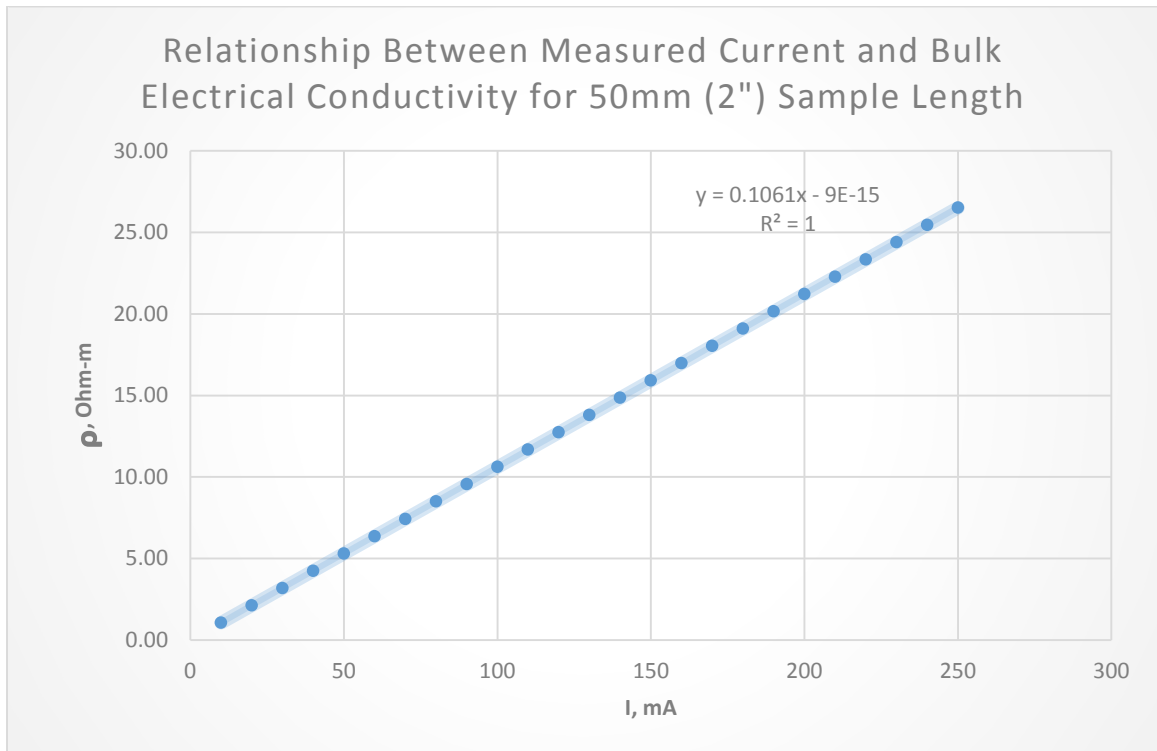
**Chart A.1: Relationship between Measured Current and Bulk Electrical Conductivity for 50mm (2") Sample Length**

Equation of the Line:  $\rho = \left( \frac{1273.03L}{VD^2} \right) I$  where  $\left( \frac{1273.03L}{VD^2} \right) = 0.1061$

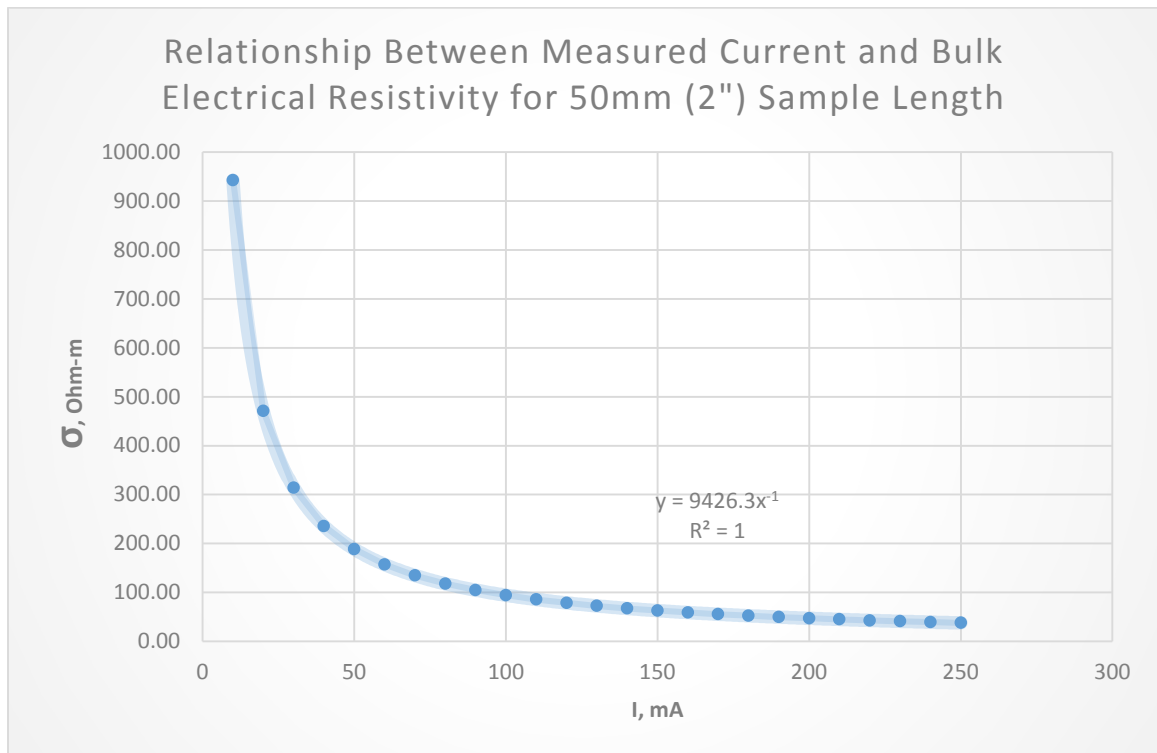
**Chart A.2: Relationship between Measured Current and Bulk Electrical Resistivity for 50mm (2") Sample Length**

Equation of the Line:  $\sigma = \left( \frac{VD^2}{1273.03L} \right) I^{-1}$  where  $\left( \frac{VD^2}{1273.03L} \right) = 9426.3$

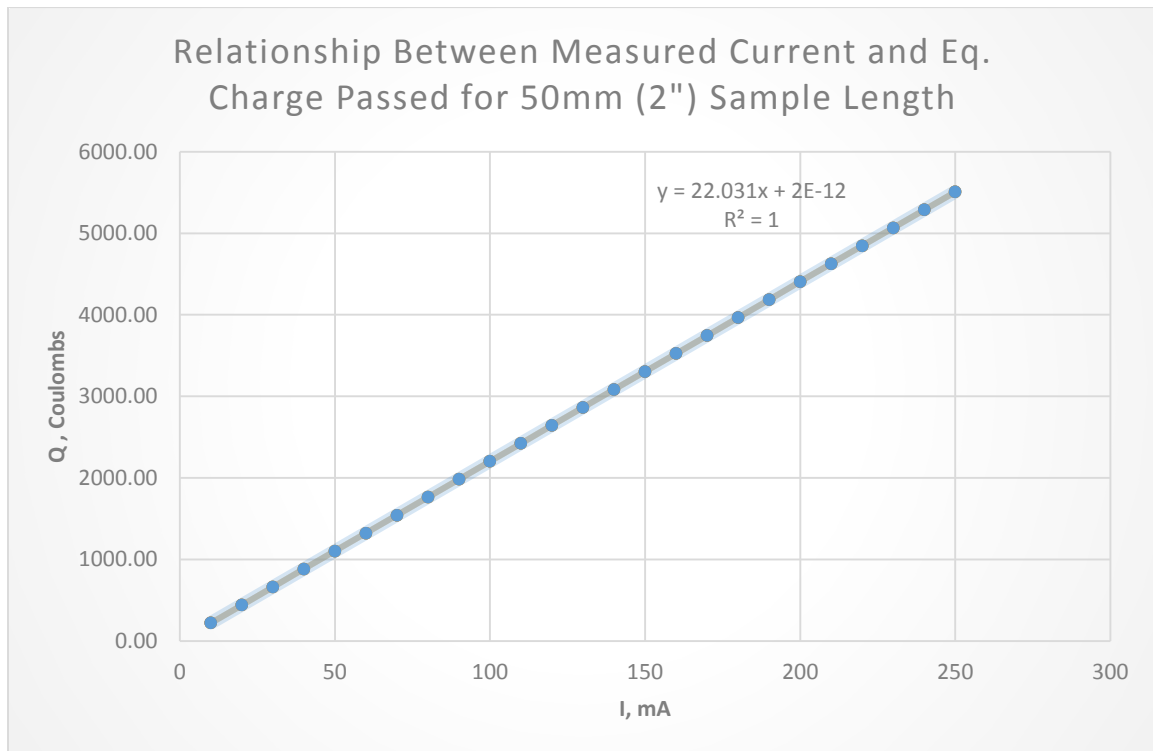
**Chart A.3: Relationship between Measured Current and Equivalent Charge Passed Over 6 hr for 50mm (2") Sample Length**

Equation of the Line:  $Q = \left( \frac{1273.03\pi T}{4 \times 10^6} \right) I$  where  $\left( \frac{1273.03\pi T}{4 \times 10^6} \right) = 22.031$

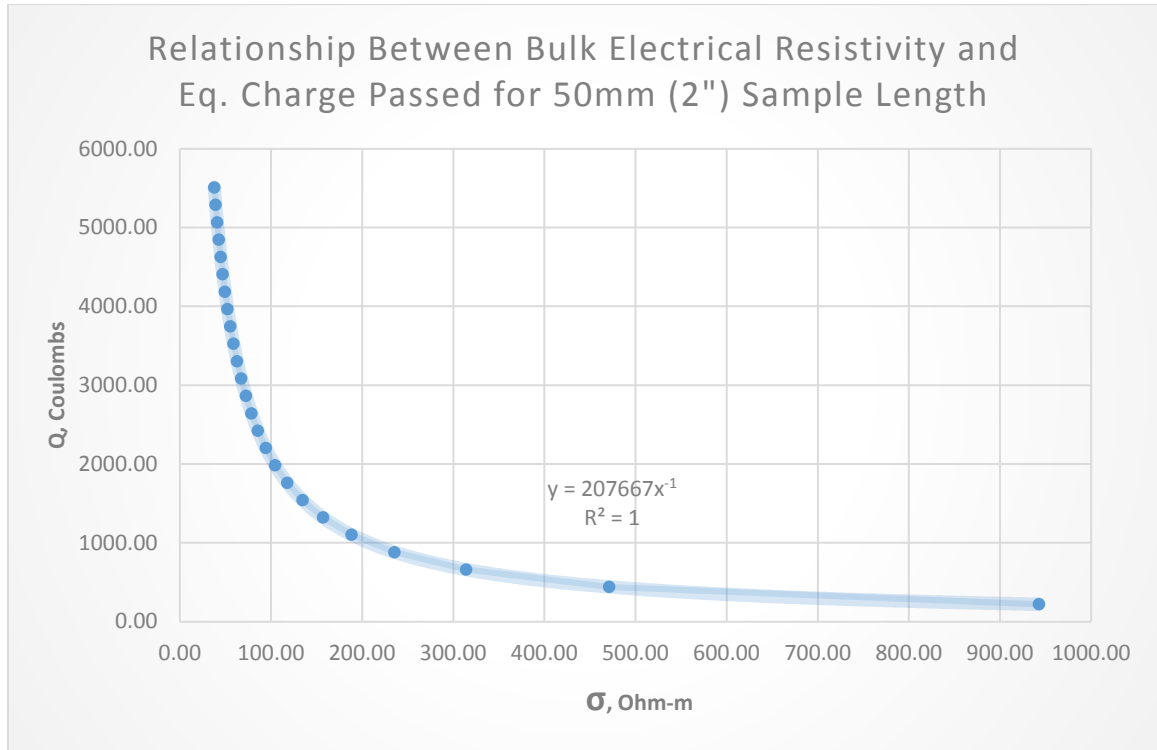
**Chart A.4: Relationship between Measured Current and Equivalent Charge Passed Over 6 hr for 50mm (2") Sample Length**

Equation of the Line:  $Q = \left( \frac{V*SA*T}{L*10^3} \right) \sigma^{-1}$  where  $\left( \frac{V*SA*T}{L*10^3} \right) = 207667$
