**The Effects of Low Dam Removal and  
Kayak Run Installation on the Biodiversity  
of Fish and Macroinvertebrates  
in the Great Miami River  
in Downtown Dayton, Ohio**

Honors Thesis

Sarah Anne Stalder

April 2016

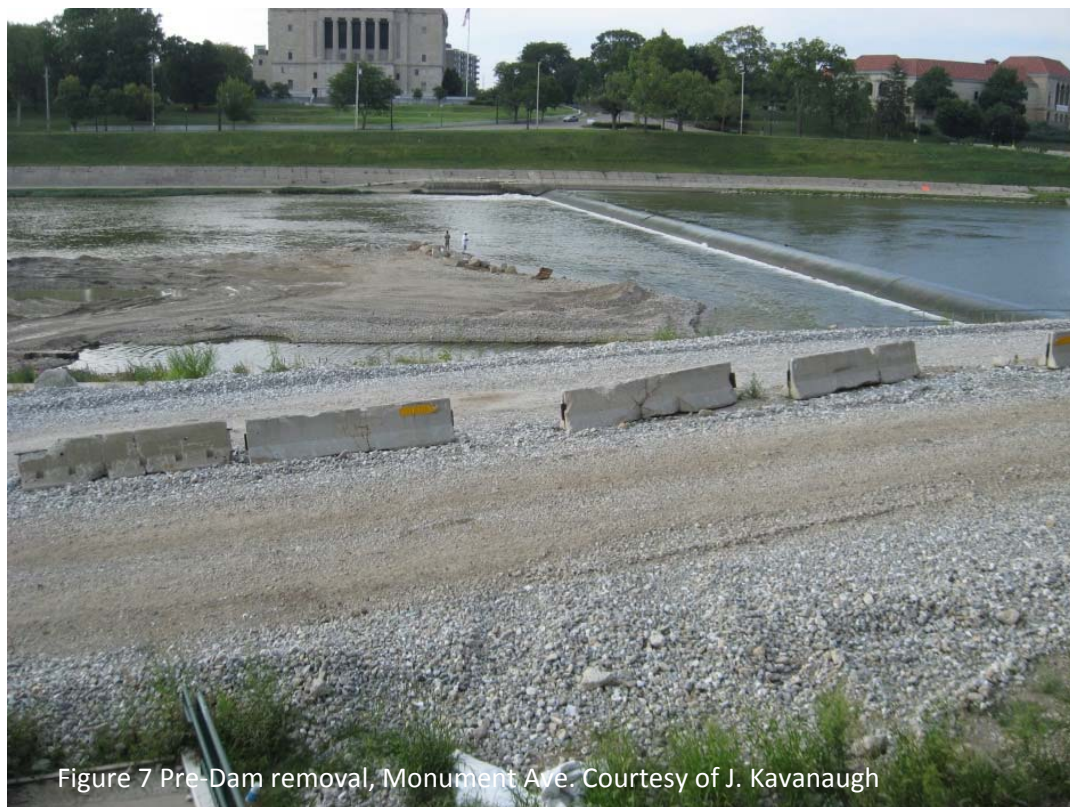
Figure 7 Pre-Dam removal, Monument Ave. Courtesy of J. Kavanaugh

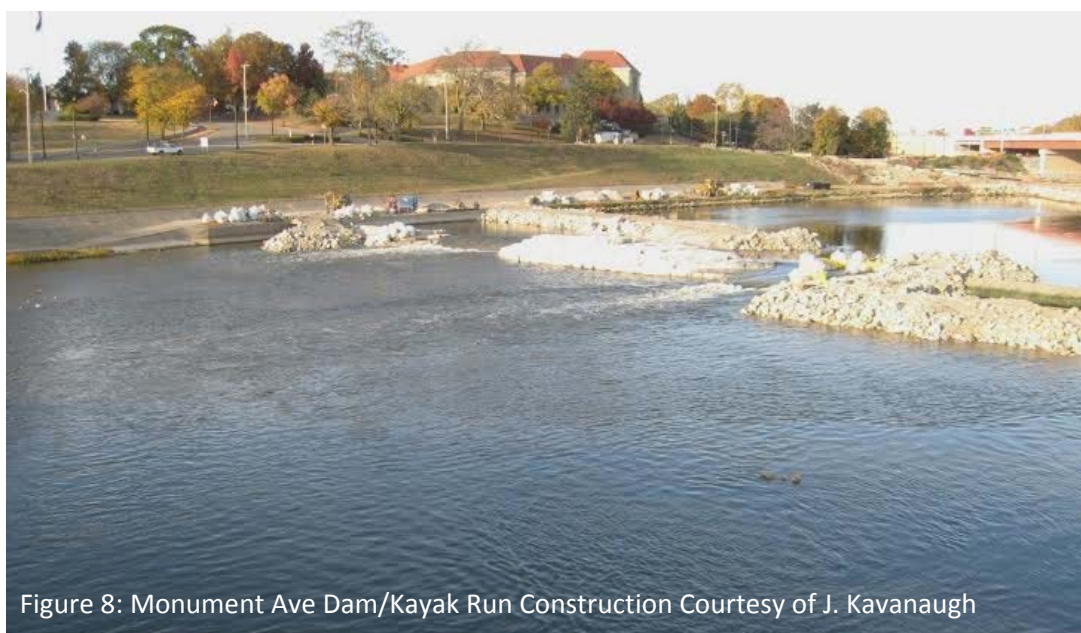
Figure 8: Monument Ave Dam/Kayak Run Construction Courtesy of J. Kavanaugh
